(54) **INFRARED RADIOMETRIC IMAGING INSPECTION OF STEEL PARTS**

(71) Applicant: **Bell Helicopter Textron Inc.**, Fort Worth, TX (US)

One example of a method includes heating a ground steel part that has been chemical-etched. The method also includes detecting defects caused by grinding and watermarks caused by chemical etching by imaging the steel part with an infrared camera to capture infrared radiation from regions of the steel part that include defects and watermarks. Imaging the steel part can include imaging regions of the steel part at long-wavelengths of infrared radiation to detect defects on the regions of the steel part and generating a first image wherein the defects are visible in the image and the watermarks are not visible in the image.

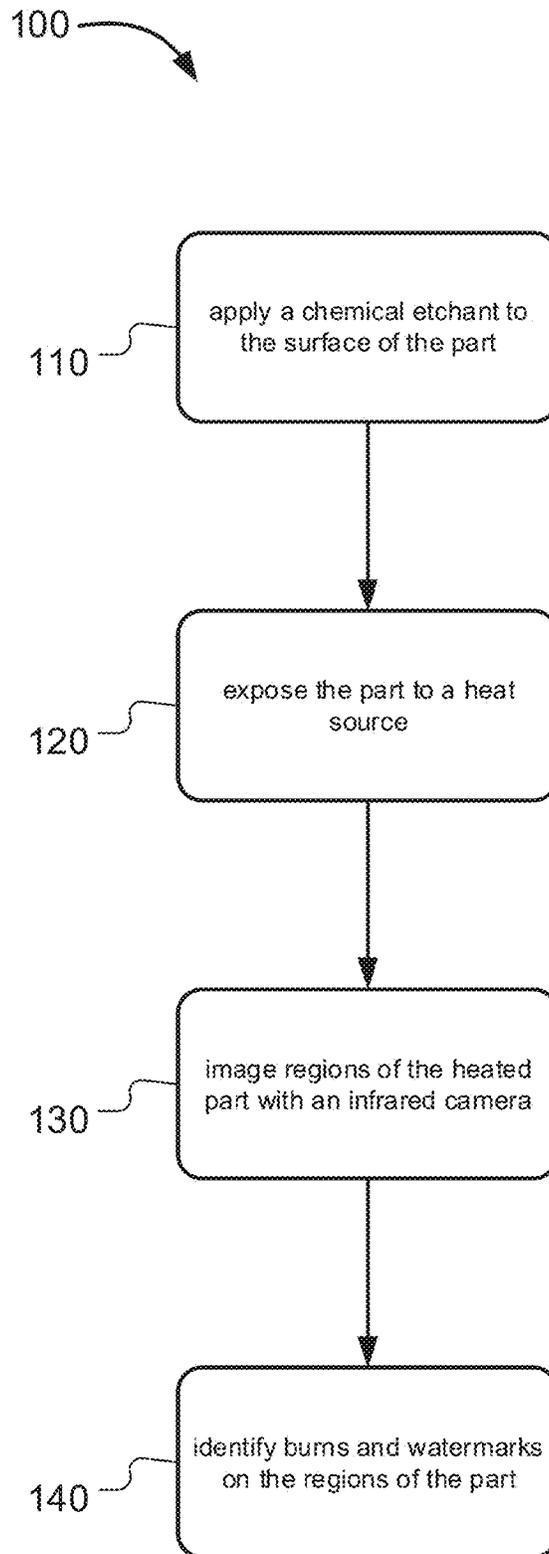
FIG. 1 is a flowchart showing an example process for inspecting a part.

FIG. 1 shows an example infrared inspection process **100**. The inspection process **100** can be used to inspect a machined, ground, or otherwise processed metallic part, e.g., a hardened steel part or other metallic part. For example, the part can be any metallic part manufactured by grinding such as a gear, shaft, spline, bearing, screw, rod, or other part. For example, the part can be a ground gear used in a rotorcraft transmission.

At **120**, the chemical-etched part is heated by exposure to a heat source. For example, the part can be heated to a temperature greater than the ambient temperature (e.g., greater than room temperature). In some implementations, the entire part is heated to a temperature, and in some implementations, a portion of the part is heated to a temperature. The part can be heated by any suitable heat source, such as the light source **204** shown in FIG. 2A or the heat source **210** shown in FIG. 2B, or another heat source.

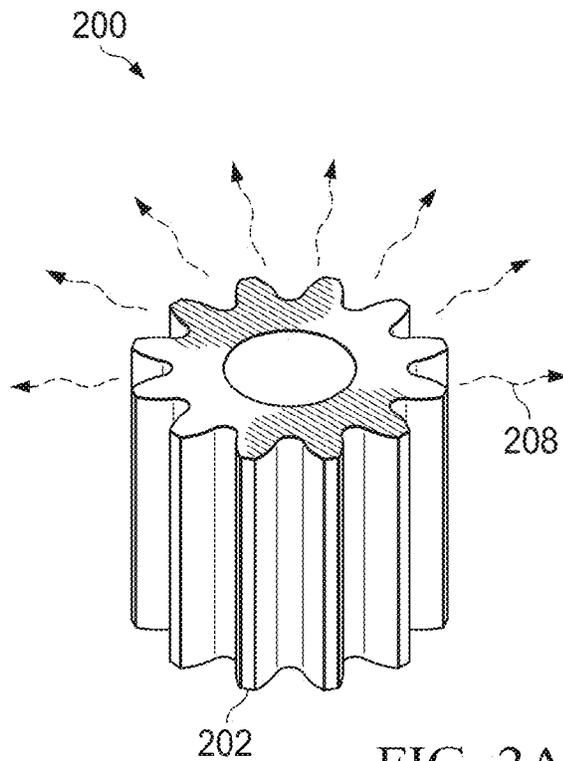
FIGS. 2A-2B are schematic diagrams showing examples of a system for inspecting a part.

FIG. 2A and FIG. 2B illustrate schematic diagrams of example inspection systems **200** and **250**, respectively. The example inspection systems **200**, **250** can implement the inspection process **100**. Each of the example inspection systems **200**, **250** includes an example part **202** and an example infrared camera **206**. In FIGS. 2A-B, the part **202** is shown as a ground gear that has been chemical-etched.

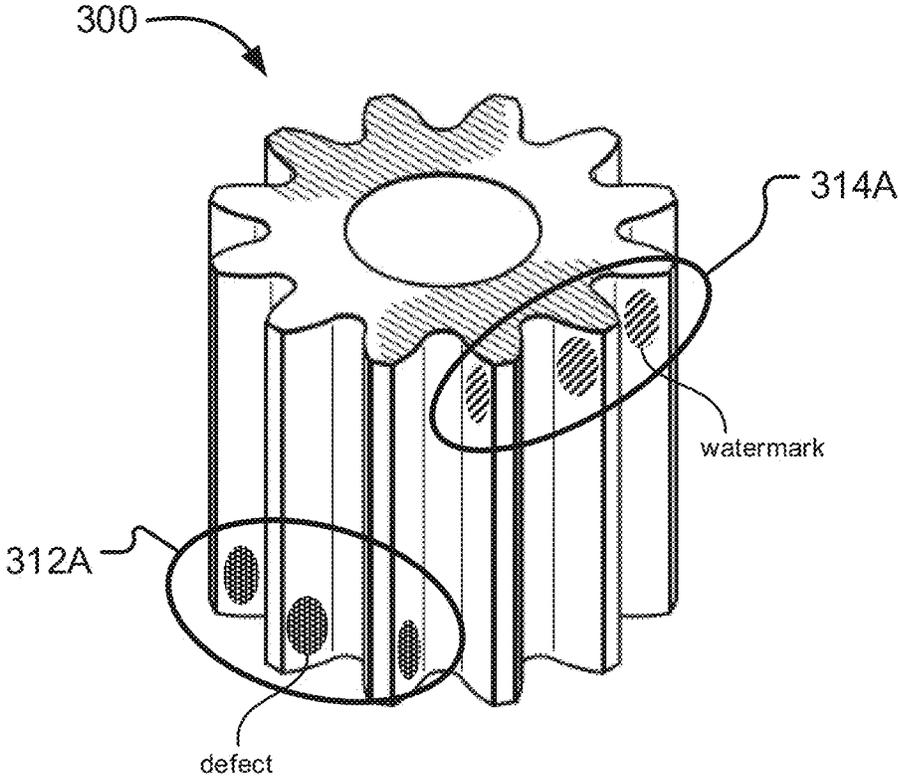
FIG. 3A is a schematic diagram of an example part inspection.

FIG. 3A shows a schematic diagram of an example part **300** as seen in the visible spectrum. The example part **300** has been ground and chemical-etched with nital etch. Representative defects are apparent on part **300** at region **312A**. The defects in region **312A** appear as dark spots on the surface of the part **300** (one example defect is labeled). The part **300** also shows representative watermarks in region **314A**, the watermarks also appearing as dark spots (one example watermark is labeled). In FIG. 3A, the dark spots of the defects in region **312A** are similar in appearance to the dark spots of the watermarks in region **314A**, and each could possibly be misidentified as the other. FIG. 3A is representative of parts on which both defects and watermarks are apparent in the visual spectrum.

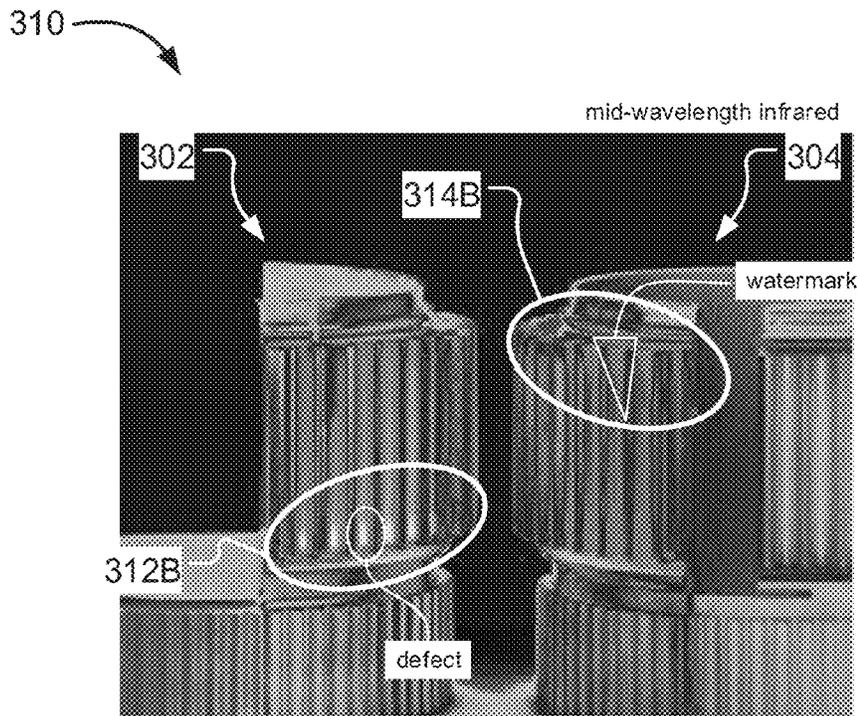
FIGS. 3B-3C are example images of a part inspection.

FIG. 3B shows an example image **310** of example parts **302** and **304** imaged with a mid-wavelength infrared camera. Parts **302** and **304** have been ground, chemical-etched with nital etch, and heated using a light source, similar to inspection system **200** implementing inspection process **100**. Image **310** in FIG. 3B is an image of mid-wavelength infrared emittance from parts **302**, **304**. In FIG. 3B, stronger intensity (shown in false-color) corresponds to greater radiative emittance from the parts **302**, **304**. The mid-wavelength infrared image **310** shows defects present in region **312B** as spots of stronger intensity (one example defect has been labeled). Watermarks are also apparent in region **314B** as spots of higher intensity (one example watermark has been labeled). Imaging in mid-wavelength infrared can show burns and watermarks with greater clarity and greater conspicuity than imaging in the visible spectrum.

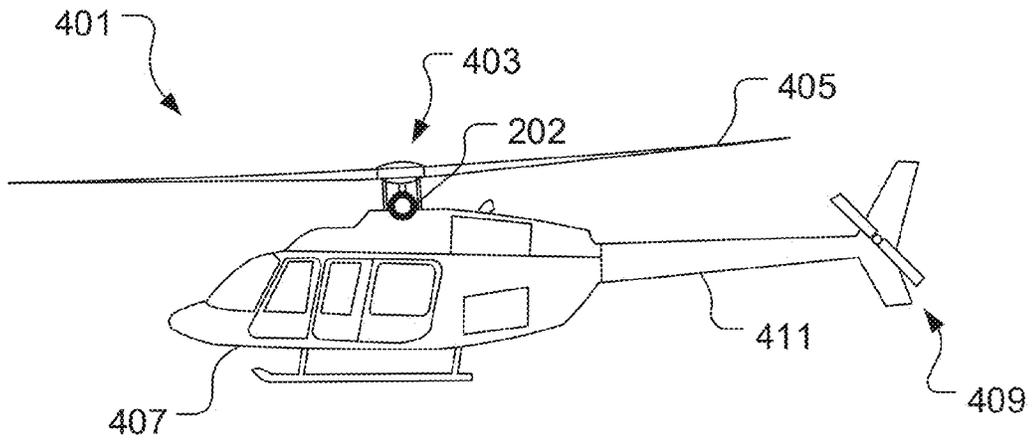
FIG. 4 is a schematic diagram showing an example of a rotorcraft.

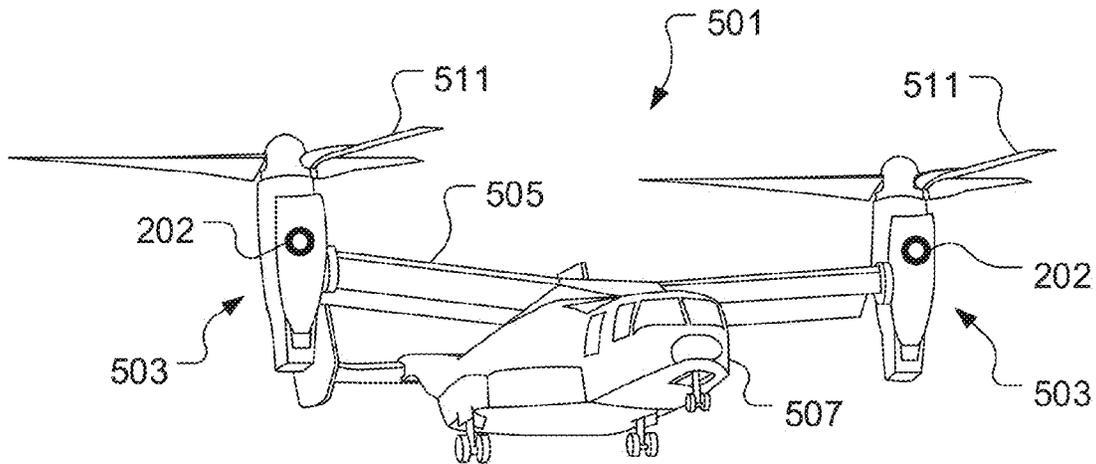
FIG. 5 is a schematic diagram showing an example of a tiltrotor aircraft.
